Manhole Inspection Summary

Manhole # S45E2_024MH

Location Address: **1530 Popland St**

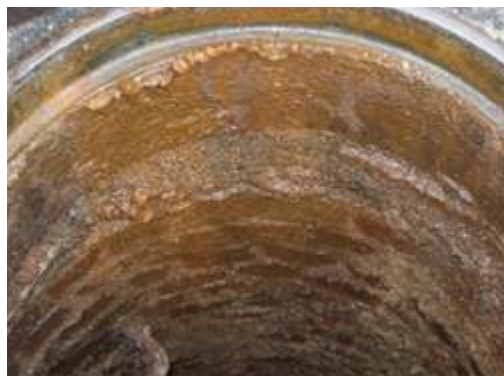
Defect 1

Offset: **1** (in.)

Frame offset

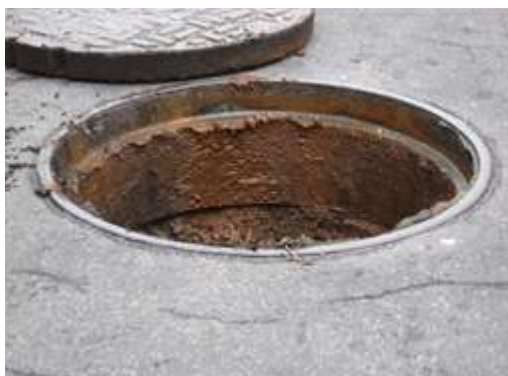
Defect 2

Diameter: **24** (in.) Length: (in.) Dist A/B Grade: **0.5** (in.)

Above grade

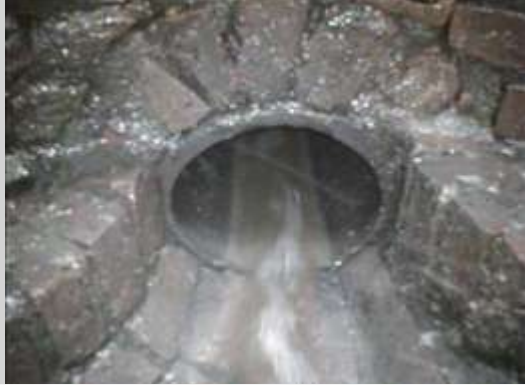
12 O'Clock Outflow

8 in. Circular Gravity Sewer
Pipe Out @ 12 O'Clock

Pipe Height: **10.8** (in.) Rod and Bar (Angled)
Pipe Material: **DIP/CI** ☐ Pipe Lined
Invert Depth: **9.80** (ft.) Flow Characteristics: **Fast**
Deposits: ☒ None ☐ Mud ☐ Sludge ☐ Debris ☐ Grease
Silt Depth: (in.) Deposits Extent:
Infiltration: **None** Pipe Seal Cond: **Sound**

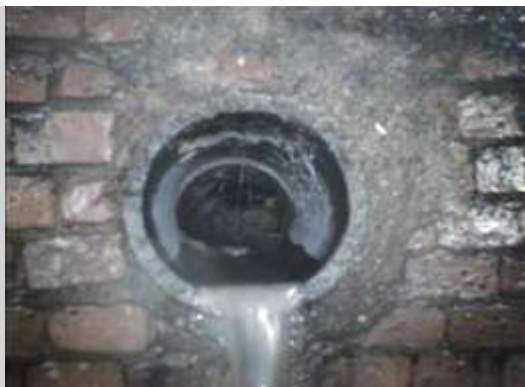
3 O'Clock Inflow

8 in. Circular Gravity Sewer
Pipe In @ 3 O'Clock

Pipe Height: **10.8** (in.) Rod and Bar (Angled)
Pipe Material: **DIP/CI** ☐ Pipe Lined
Invert Depth: **6.98** (ft.) Flow Characteristics: **Fast**
Deposits: ☒ None ☐ Mud ☐ Sludge ☐ Debris ☐ Grease
Silt Depth: (in.) Deposits Extent:
Infiltration: **None** Pipe Seal Cond: **Sound**

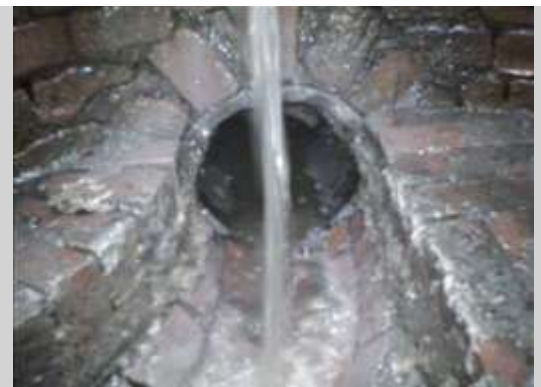
Drop In @ 3 O'Clock

Drop: **Outside** Rod and Bar
Angled: **Yes** Reading: **8.61** (ft.)
Inv Depth: **9.61** (ft.)
Drop Condition: **Open**

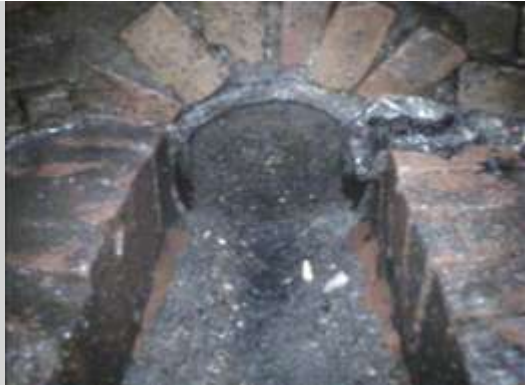
6 O'Clock Inflow

8 in. Circular Service Sewer
Pipe In @ 6 O'Clock

Pipe Height: **9.6** (in.) Rod and Bar (Angled)

Invert Depth: **9.57** (ft.) Flow Characteristics: **None**

Infiltration: **None** Pipe Seal Cond: **Sound**

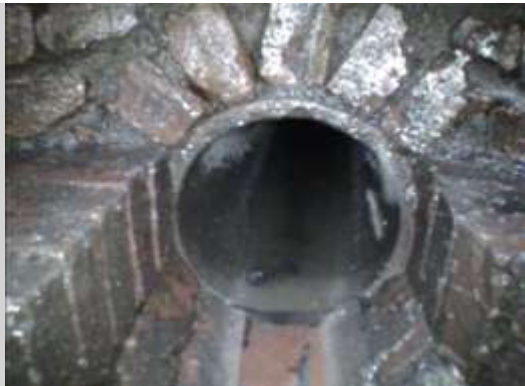
9 O'Clock Inflow

8 in. Circular Gravity Sewer
Pipe In @ 9 O'Clock

Pipe Height: **12** (in.) Rod and Bar (Angled)

Invert Depth: **9.68** (ft.) Flow Characteristics: **Fast**

Infiltration: **None** Pipe Seal Cond: **Sound**
